March 1, 2007
31 chevy progress - 13th status

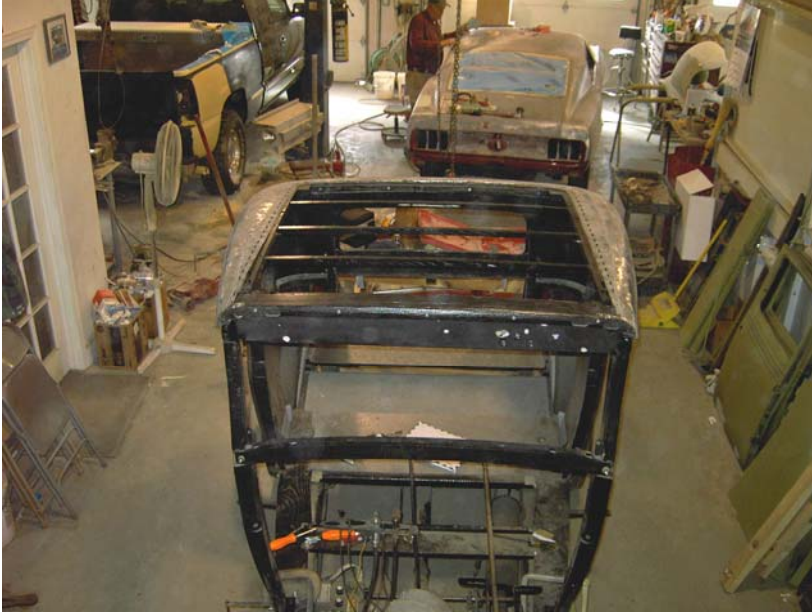
I received the wood that forms the top of the body and installed it. I then checked the doors for fit and found major problems. Nothing lined up. After examining several pictures of the wooden framework in other cars, I realized that some of my wood had been modified. The roof rail pieces had been shortened at the front where they meet the wood above the windshield. Other pieces didn't fit correctly when I attempted to install the cowl. I obtained measurements from my wood supplier's patterns and determined that pieces that fit in the cowl were not made properly, so I ordered additional pieces. Hopefully, I will receive them in a couple weeks. The incorrect pieces were made by another east coast wood manufacturer.
