26th Status
June 17, 2008

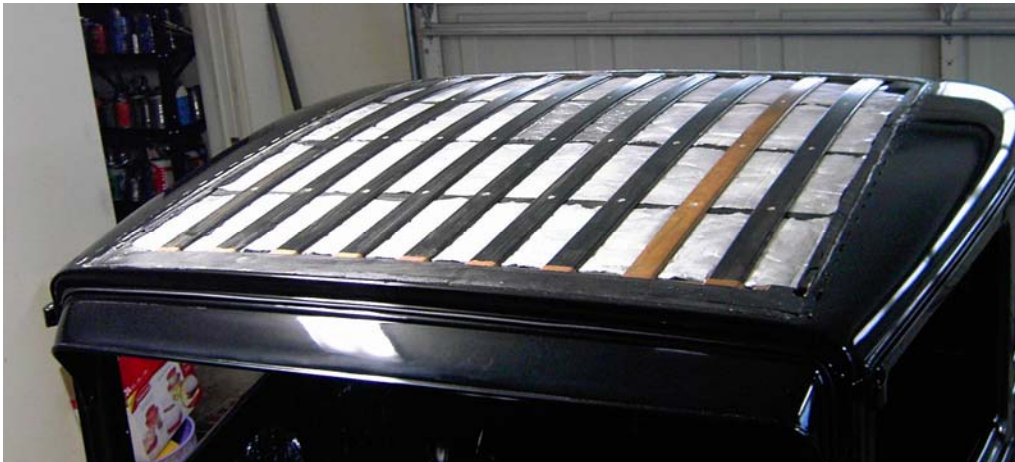
The wooden top bows and slats are now installed. The bows run from side-to-side, and the slats run back to front. One slat is a different color, because I lost one and had to make another. It was already varnished, so I didn't paint it. The slats are screwed to the bows and secured with strips of copper at front and back.

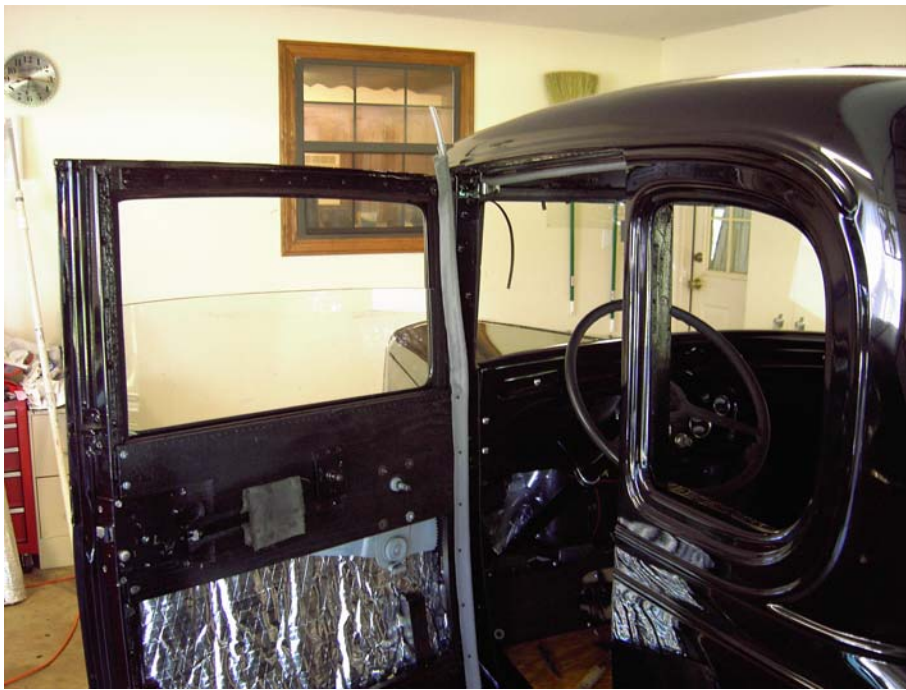
Most of the glass is now installed. The window regulators and sashes (or metal channels) were bead blasted and repainted several months ago, and the wooden regulator boards were repainted. Regulators and latch mechanisms were reinstalled on the boards. My friend Carl cut new safety glass using the original pieces as patterns, and we installed them in the sashes. The old windshield was too damaged to use as a pattern, but a Vintage Chevrolet Club member sent a paper one, which was used to make a plywood pattern to assure a proper fit against the cowl. The plywood pattern was then used to cut the glass. Even after all that effort, it was necessary to trim the bottom of the glass slightly to make it fit against the cowl. Rubber window channels and felt were installed in the doors and back window. The rear window pattern was not wide enough from side-to-side, which resulted in the new glass being loose in its rubber

side channels. So Carl cut a new piece ¼” wider, which fits and works perfectly. Glass is installed and can be rolled up and down in the doors and back window. The windshield glass is installed, along with its rubber channels. It will be operational after upholstery is attached to the windshield regulator board, and it is installed in the body. A “U” shaped rubber channel was stretched around each rear quarter window pane, assuring that all kinks in the rubber were stretched out. It was then cut to length, removed from the glass, and the two ends were super-glued together. After the super glue cured, the rubber was re-stretched around the glass for a perfect fit. The quarter windows will be installed after upholstery is installed in that area.

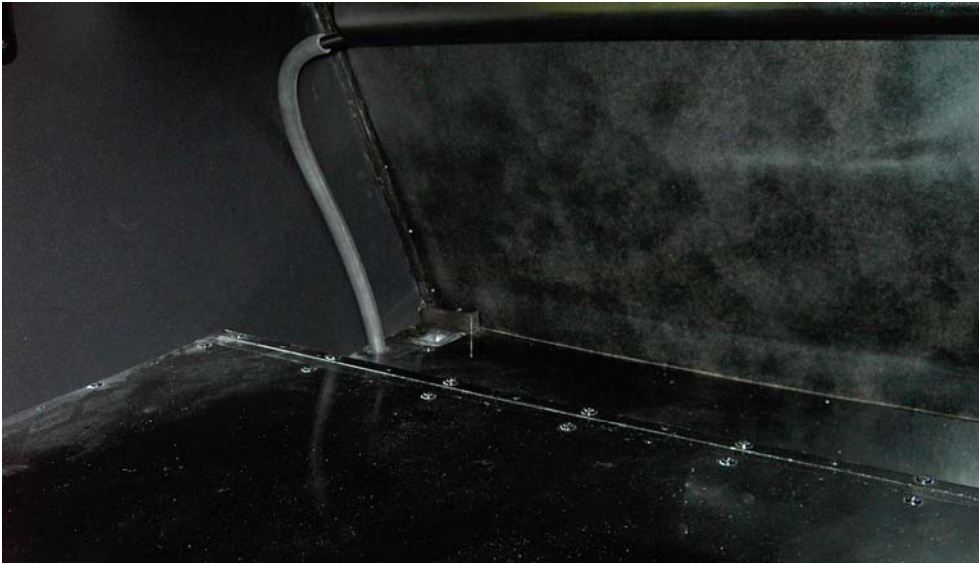
The Trunk Kit has been installed. Basically, it’s three large pieces of black cardboard that line the trunk area. It was amazing to see how well they fit after the wooden supports were installed. The rubber hose routes rain water from the gutter under the rear window down to the wooden floor sill and out of the body.
