24<sup>th</sup> status  
March 21, 2008

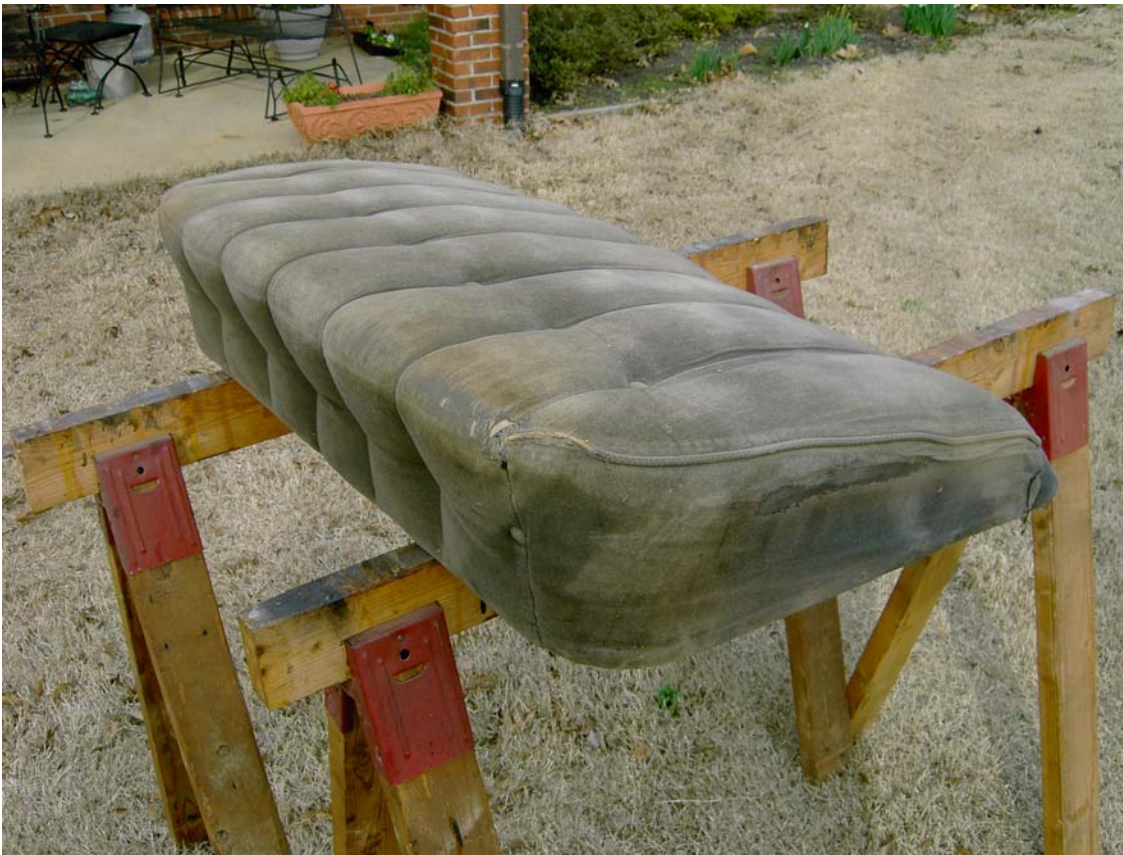
The seat has taken a lot of time over the last couple months. Two layers of old seat covers were removed from the bottom cushion to expose the original mohair upholstery with two rows of buttons (see picture). This may be the original the seat cushion for the car, or maybe it was replaced with this cushion, years ago? Additional research will be needed to determine if one or two rows of buttons is correct for this model (Job #31567).

The cushion was disassembled to remove its wooden base, which was in several pieces and had to be glued back together. Two coil springs were broken, so a new set of springs will be ordered. Thankfully, the back rest springs were still in good shape. I wire brushed them in a few places to remove minor surface rust and treated them with rust converter paint.

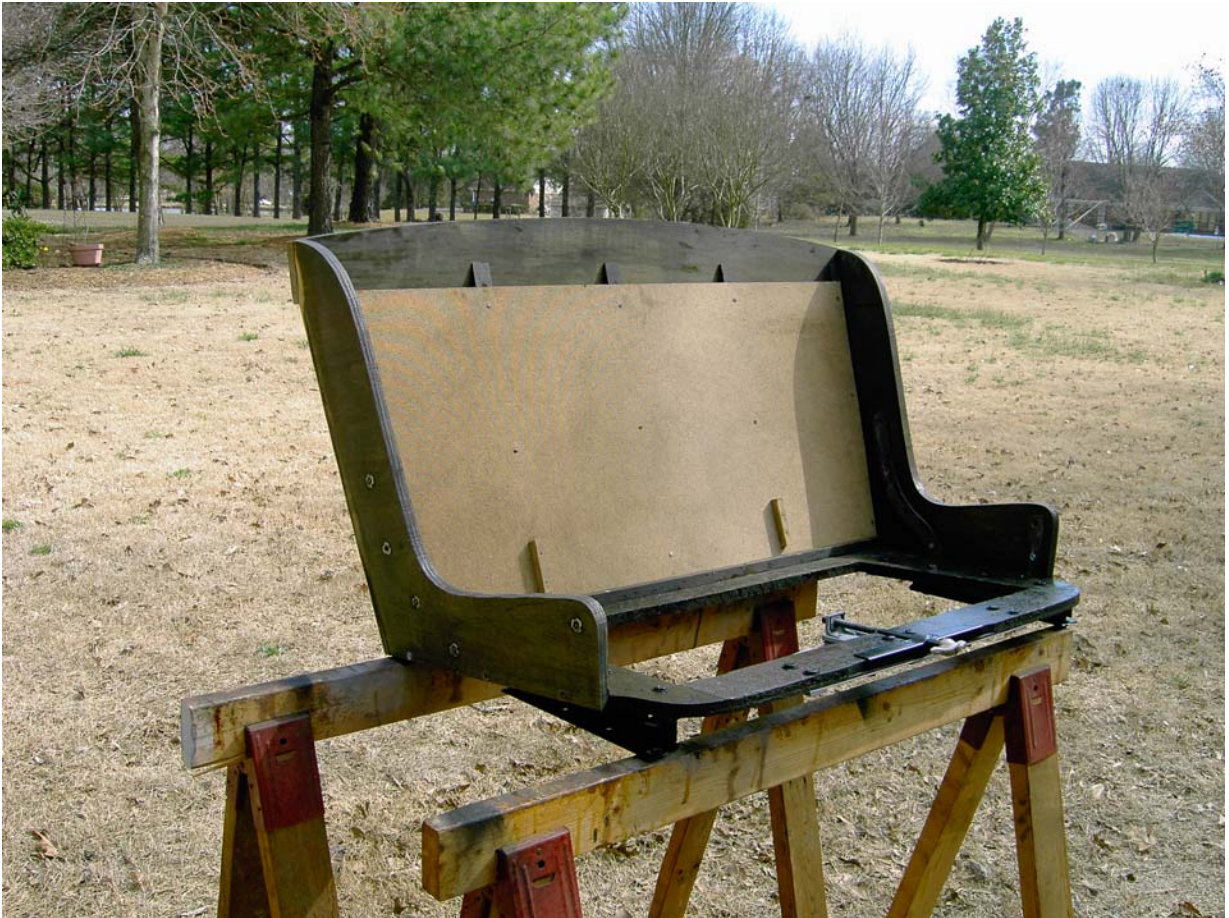
The wooden seat frame required lots of work. It was disassembled in early January. A rotten upper rail and side panel were good enough for patterns, and with help from my woodworking friend John, they were replaced with new wood. The bottom panel was in several pieces, but I was able to glue it back together. The back panel was replaced with a new piece of masonite. The metal seat adjusting mechanism parts were blasted and repainted before reassembling the seat frame.
